RIDGEBURY LAKE DAM

( NDI I.D. No. PA-00727  
PENNDER I.D. No. 8-57 )

PHASE I INSPECTION REPORT  
NATIONAL DAM INSPECTION PROGRAM

JULY 1980

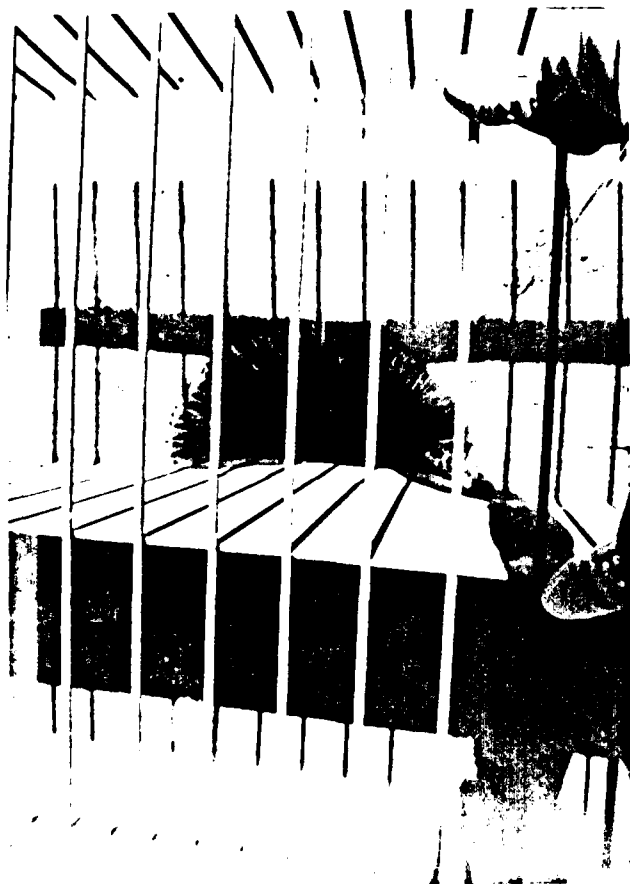
PHOTOGRAPH 5    Close-up view of the drop inlet service spillway.

PHOTOGRAPH 7    View of the area immediately downstream of the embankment as seen from the crest.

PHOTOGRAPH 8    View of the discharge end of the outlet conduit at the downstream embankment toe.

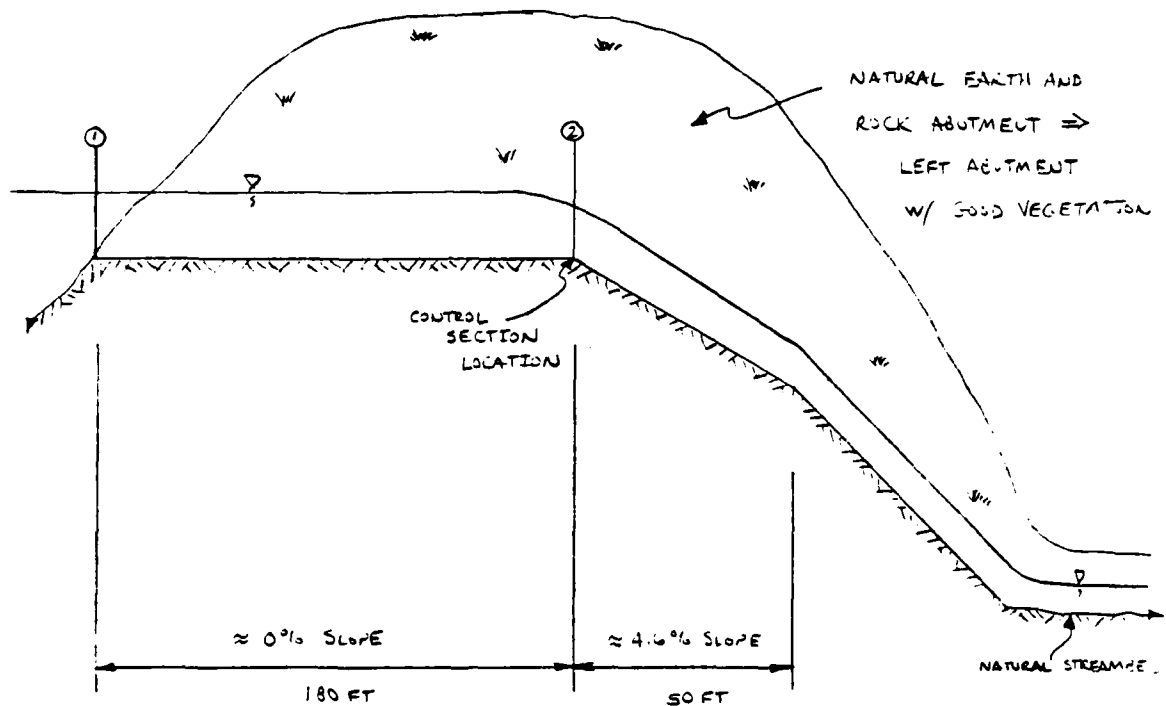
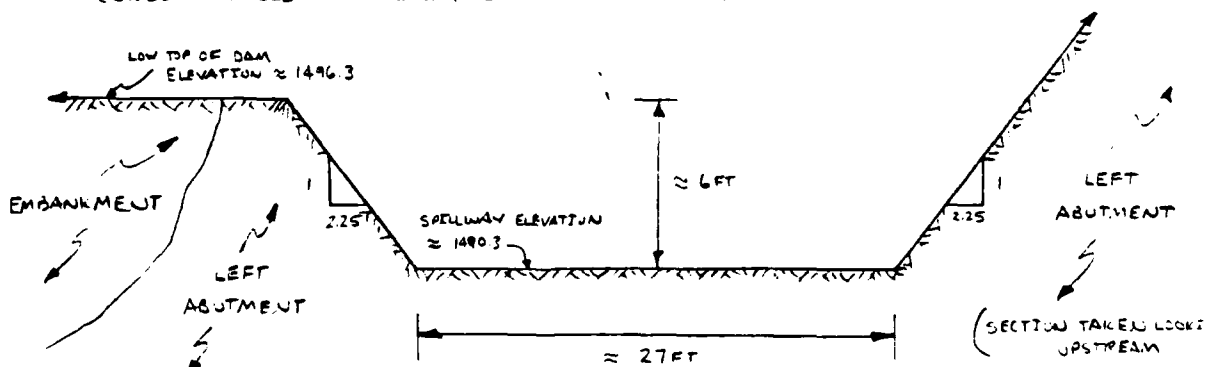
- PROFILE OF SPILLWAY : (NOT TO SCALE)  
 (BASED ON FIELD MEASUREMENT)

1. Emergency Spillway. The visual inspection revealed the emergency spillway is in fair condition. Field measurements compiled by the inspection team indicate the channel is inadequately sized and not constructed in accordance with the design drawings. An accumulation of mud and debris within the channel, that appears to be outwash from a nearby roadway culvert (see Photograph 10), and surface sloughing of soils along the left sidewall upstream of the debris area were observed.

b. Construct the spillway in accordance with the original design under the direction of a registered professional engineer experienced in the construction of earth dams or retain the services of a registered professional engineer experienced in hydrology and hydraulics to further assess the adequacy of the emergency spillway and prepare recommendations for remedial measures deemed necessary to make the facility hydraulically adequate.
